Inspection Report
Minerals Regulatory Program
Report Date: June 3, 2005

Mine Name: DKG Quarry

Diamond K Gypsum

Permit number: M/015/041

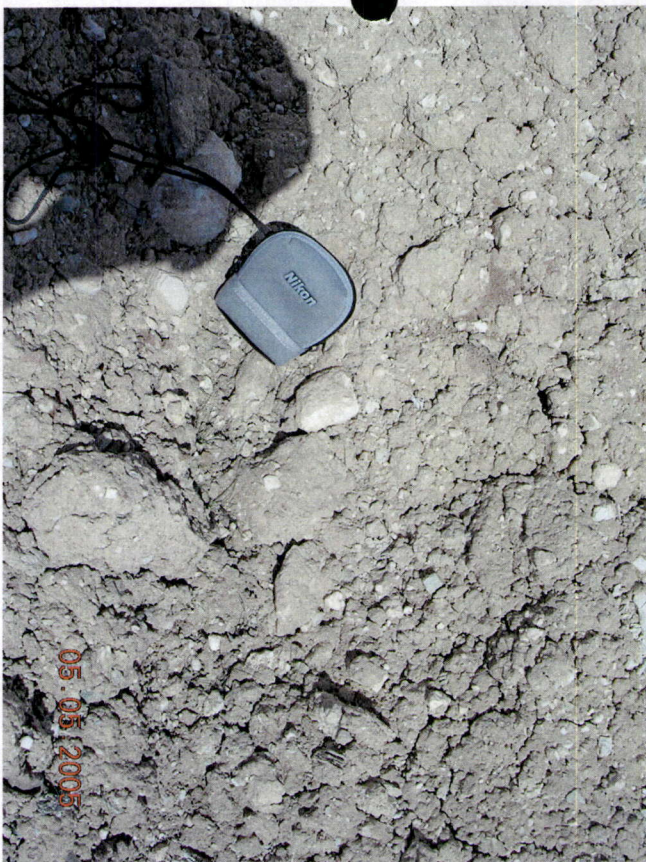
I found numerous grass seedling in the area that was regraded and seeded in 2004. These did not look like cheatgrass or some other weed; I believe they were seeded species. Some of the seedlings may be just visible in Photo 1. With normal precipitation, I expect these seedlings to become established.

Photo 1. This was an attempt to photograph grass seedlings, but they don't show up well.

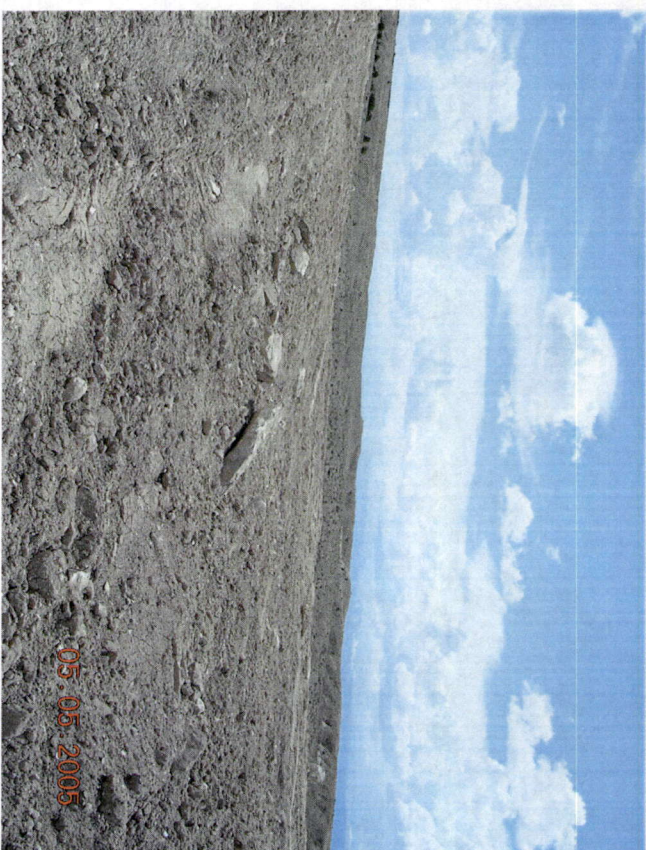
Photo 2. An overview of a portion of the reclaimed area.
